# North Carolina Department of Administration

**SUBJECT:** Assessment of Eagle Landing - Private Dormitory for NCCU  
408 Brant Street  
Durham, NC

## On-Site Survey 4-23-07 and 4-24-07 - State Construction Office

### **Eagle Landing, NCCU Private Dormitory, 408 Brant Street, Durham, N.C.**

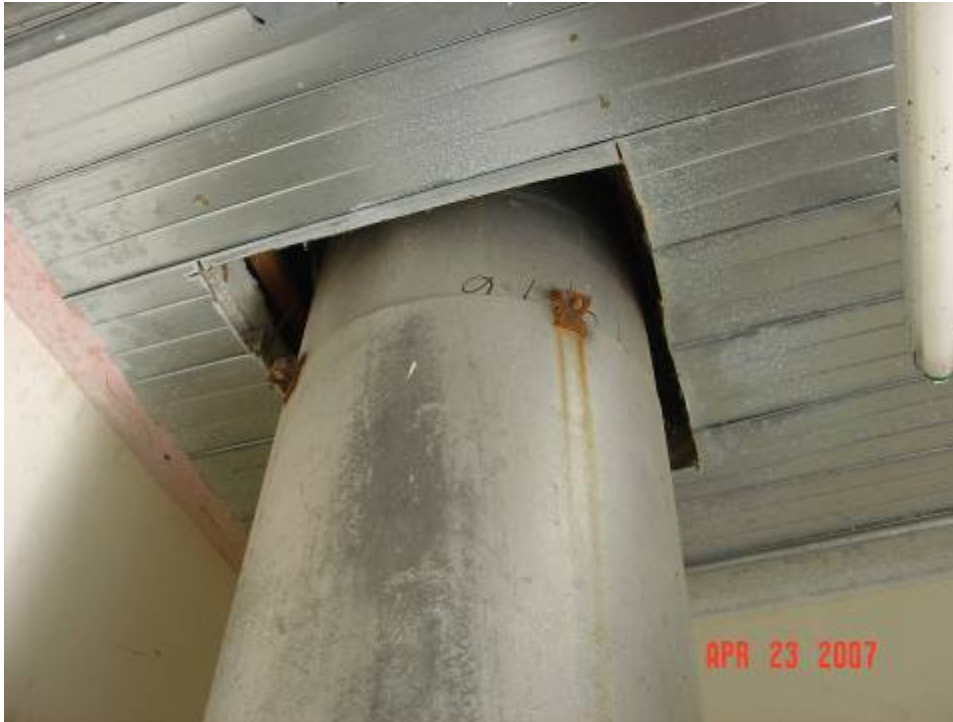
The trash chute now appears (as observed from attic access area) to have a 2-hour fire rated shaft as required by code, but it was noted that the chute termination at the first floor at hopper has not been properly sealed. Fire suppression system was noted at trash chute but protective cap over sprinkler head is still in place. The trash chute doors are presently fastened shut with screws. Should the system be reactivated, positive latching would be required at doors and fire suppression system should be properly installed and tested. Repair or retrofit trash chute and the doors to provide a positive latch at inlets. Repair existing or install a new fire suppression system and seal and install proper terminations. (\$65,000)

Bottom of trash chute chase not sealed.

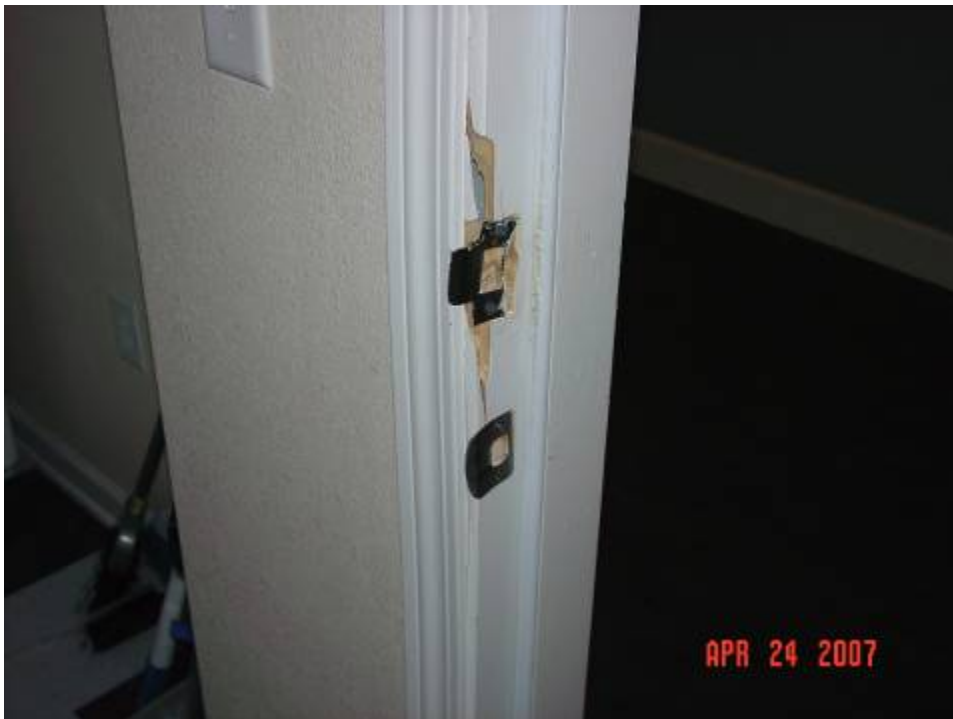
Corridor and apartment interior doors were 20 minute rated wood door jambs (residential type) with lightweight 90 minute rated metal doors (rating information gleaned from tags on doors) with residential-style wood door casings. Hardware consists of light duty cylindrical locksets with spring hinges for closure function. Few doors had door mounted closers. The majority of doors showed evidence of extreme wear and poor fit and finish. Hinge screws have pulled loose and spring hinges have lost the ability to close and latch the doors properly.

Residential-type wood door jamb and casing.

It is recommend that corridor and apartment interior doors, frames and hardware be removed and replaced with properly set and secured, hollow metal door frames (rated as required) with commercial/institutional grade solid core wood doors, hinges, mortise locksets (with ADA compliant lever handles) and surface mounted door closers.

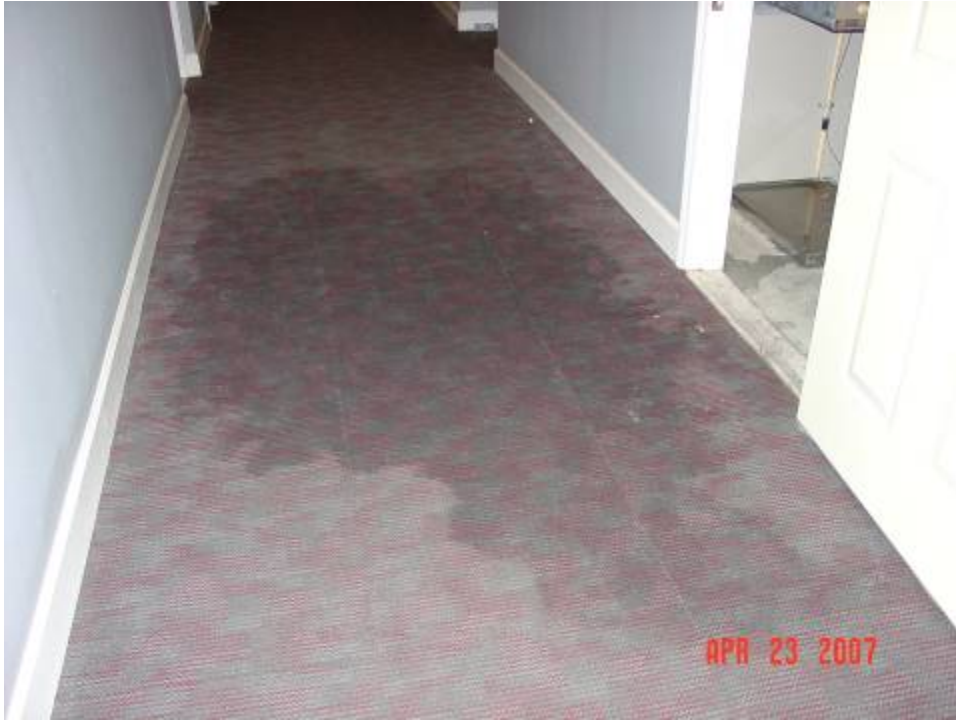
Carpet is wet/stained at corridors and apartments from condensate leaks at nearby mechanical rooms. Leaks were noted at both walls and ceilings at several apartments.

Water damage to hallway from overflowing condensate drain pan.

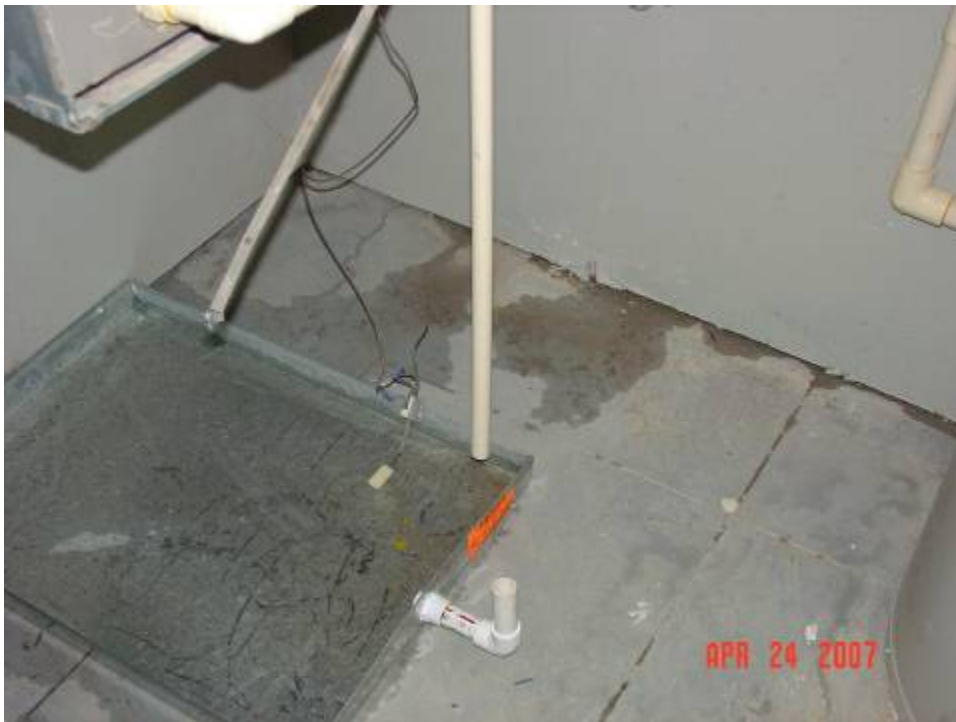
The existing condensate drain system malfunctions frequently, resulting in water damage to the building, unsanitary conditions and mold growth. The primary condensate piping clogs frequently, causing water to back up into the water heater drain pans and overflow into the mechanical rooms and flood that area of the building. The condensate piping supports do not meet NCPC Section 308.

Condensate overflow into wall cavity.

It is therefore recommended that the primary and secondary condensate removal system be renovated to provide a reliable system that will not become clogged and flood the building, and meets NCMC Section 307.

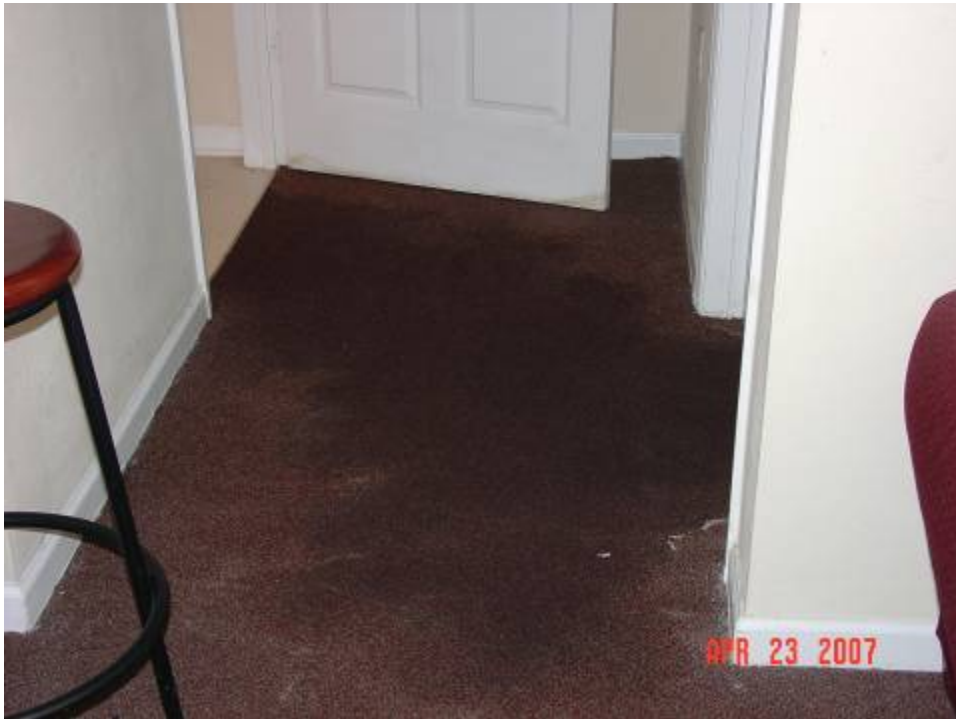
Water damage in student suite from plumbing leak.

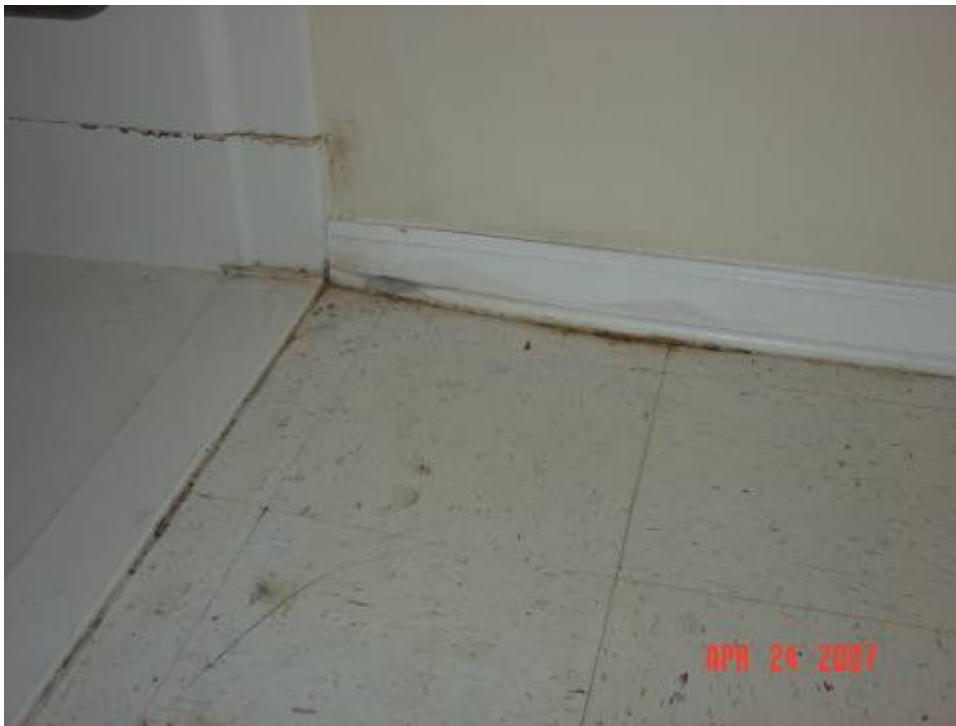
Walls adjacent to handicap shower stalls in dormitory rooms are showing signs of moisture damage; and they do not appear to have a non absorbent surface and waterproof joints as required by Sections 1209.3 and 1209.4 of the NC Building Code. Please refer to item G-1 for recommendation related to excessive moisture damage. Height of toilet paper dispensers in men's restroom do not comply with mounting height specified in the NC Accessibility Code, Chapter 11, and Section 11.6.1 (5). Wall mounted sinks in women's restroom are loose and need securing. It is recommended that wall-mounted sinks be removed, and wall blocking be added/installed at both men and women's rooms. Reinstall sinks and patch and repair damaged gypsum board and finishes. (\$ 3,500)

Moisture damage from shower.

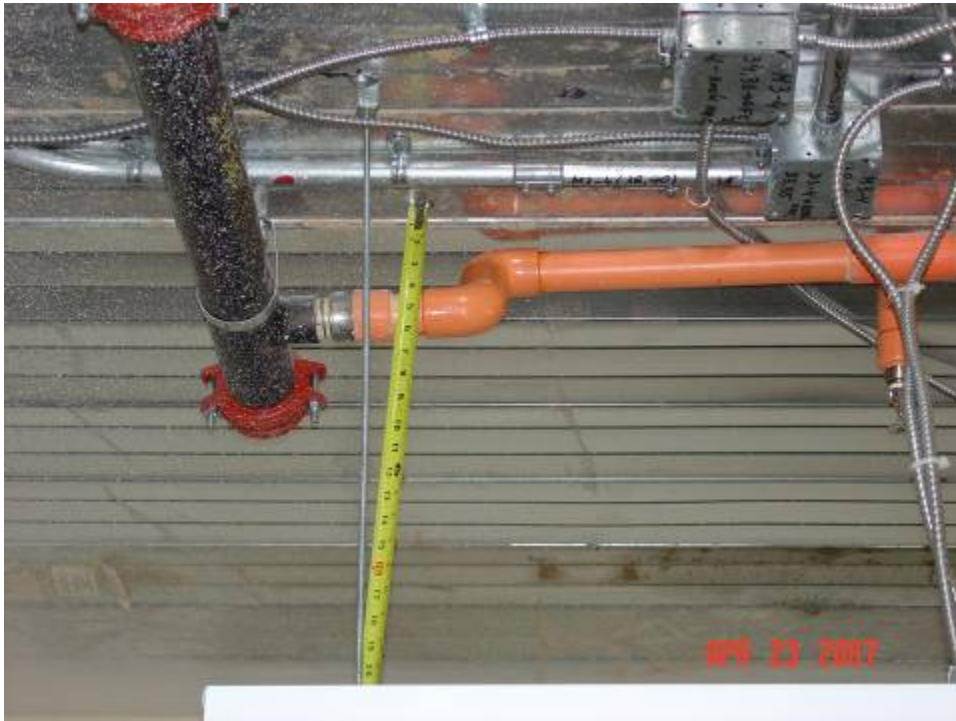
NFPA documents from the original construction still have not been provided, and a functional test could not be performed on the system during this inspection. The sprinkler system in this building uses plastic piping suspended from hangers. According to NFPA 13 and standard UL listings, plastic piping for sprinkler systems must be protected from the covered space or run along a smooth, flat, horizontal ceiling. The existing plastic pipe suspended from hangers does not meet NFPA 13 requirements and UL listings.

Plastic sprinkler pipe not routed flush to ceiling.

It is therefore recommended that the routing of sprinkler piping be modified to run flush against ceilings. Existing sprinkler heads should be repaired and new heads added, such as for the trash chute enclosure, as needed to provide proper coverage for the building. All sprinkler piping in the building should be adequately supported, including seismic restraints as required by code.

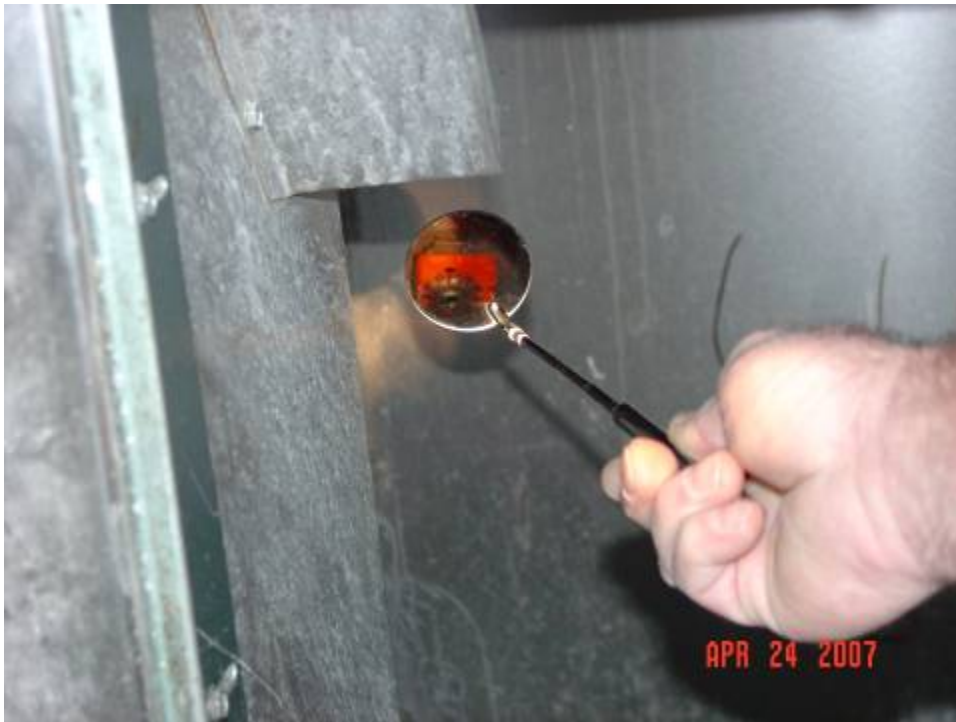
Fire sprinkler heads appear to be inoperable at several locations. Plastic tabs from original construction cover many of the links, paint has been splattered on heads, heads designed to be exposed have been mounted recessed into the ceiling, and escutcheon plates are missing on many heads. The sprinkler standpipes in the stairwells are not properly supported as required by NCPC Section 308 and NFPA 14. The main sprinkler risers and piping need to be evaluated for seismic support according to the NCPC 308.2. A sprinkler head needs to be installed at the top of the trash chute, which is a high risk location for a potential fire.

Plastic tab covering sprinkler head fusible link.

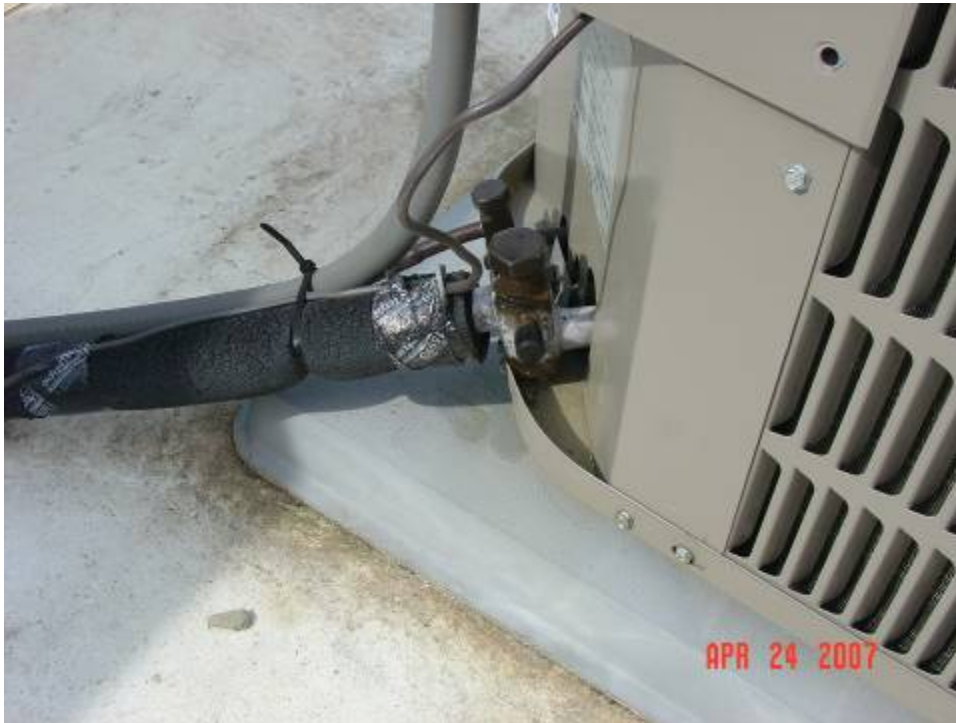
The refrigerant piping to each heat pump on the roof appears to be more than 150 feet in length, which is excessive. The connections at the heat pumps indicate that the refrigerant piping has not been oversized to account for excessive length. The long stretches of piping strain the equipment and cause coil freezing and premature failure of the heat pumps.

Frozen suction line on heat pump.

It is therefore recommended that the HVAC equipment be replaced. The existing heat pumps, air handling units and refrigerant piping should be removed. The new system should consist of a new gas-fired boiler, electric chiller, and four-pipe chilled water and hot water piping system. This system will be more energy efficient and greatly reduce maintenance costs.

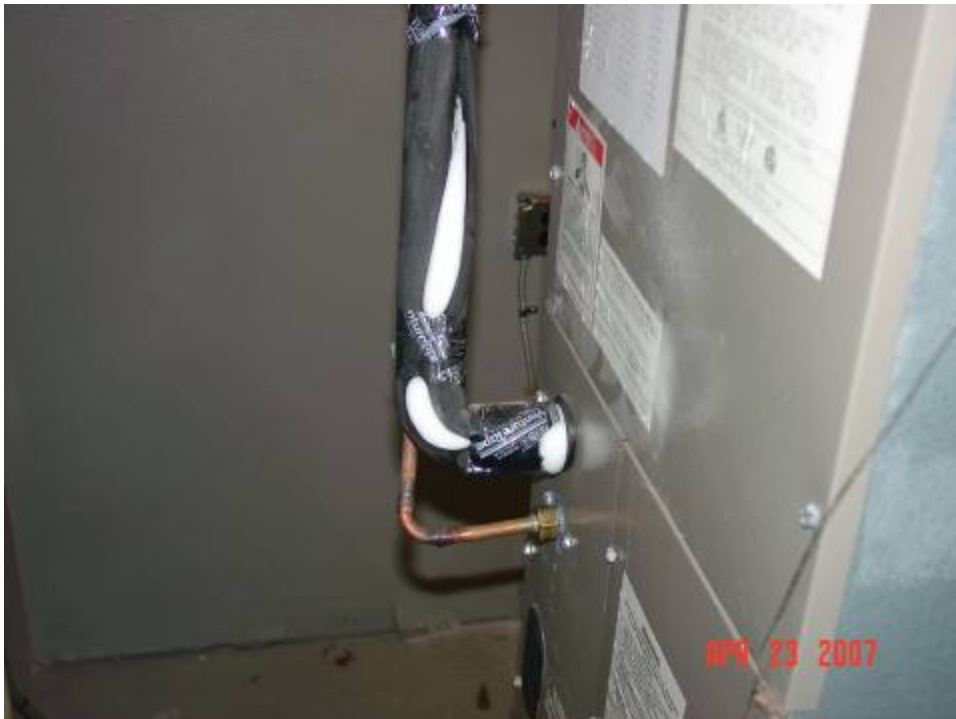
Refrigerant leaks and excessive lengths of refrigerant piping have contributed to poor performance of the HVAC system. During the recent inspection, several air handling unit coils were frozen, such that the equipment could not condition the rooms and moisture damage to the structure occurred during thawing.

Frozen suction line at air handling unit.

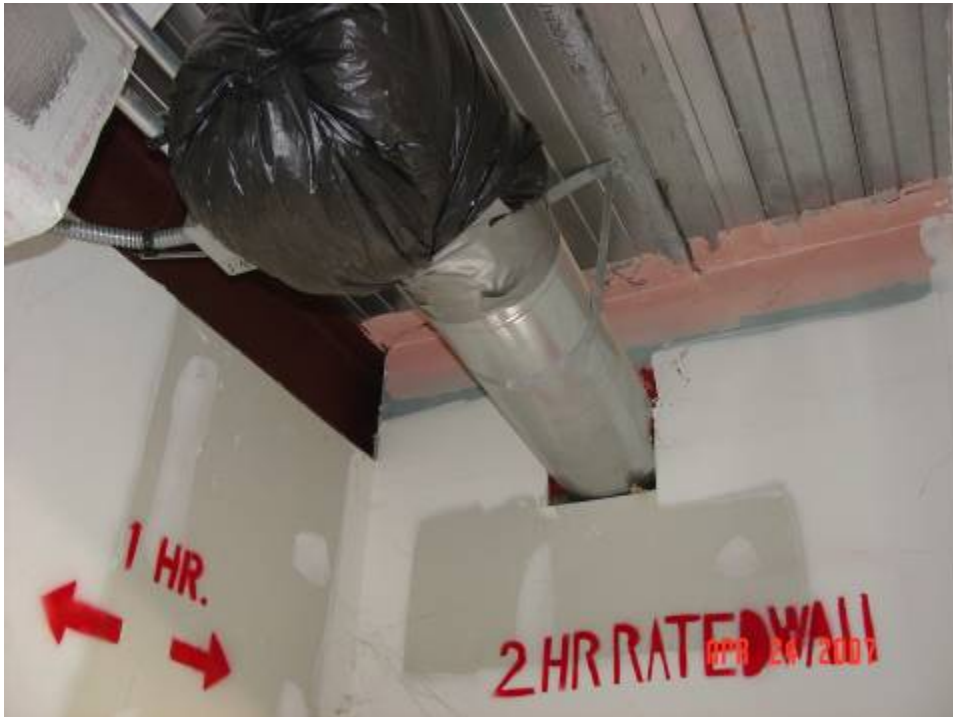
Penetrations of fire rated partitions have not been properly sealed to maintain the necessary fire rating, as required by applicable sections of the NC Building Code. Fire rated partitions are not labeled. It is recommended that all fire rated partitions be properly sealed and labeled. (\$73,000)

Fire-rated wall not properly sealed.
